**TECHNICAL EVALUATION
OF THE
OPENBAND CABLE SYSTEM
IN LOUDOUN COUNTY, VIRGINIA**

**August 2010
Draft Material
Client-Attorney Work Product
Privileged and Confidential**

Prepared by
Columbia Telecommunications Corporation
10613 Concord Street
Kensington, MD 20895
301.933.1488
www.CTCnet.us

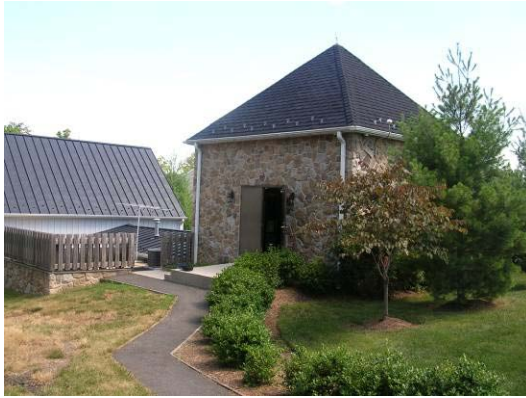
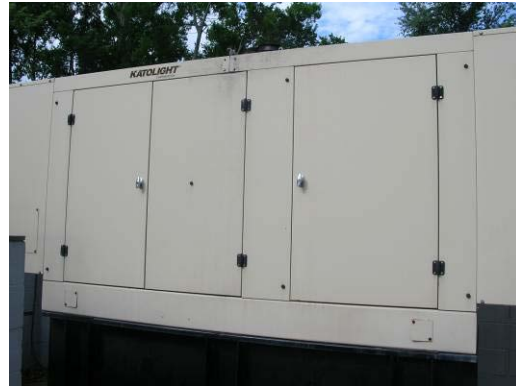
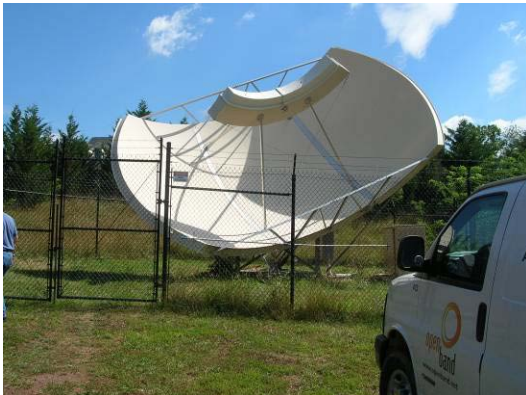
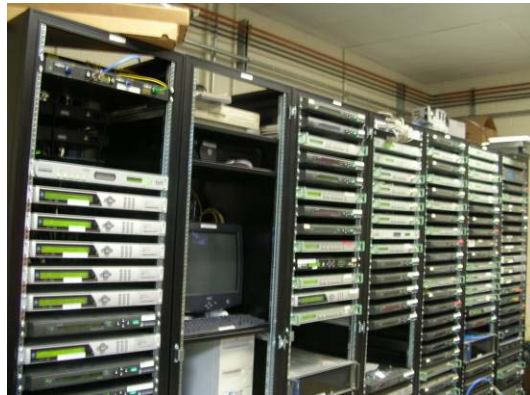
Figure 3: OpenBand Lansdowne Headend Illustrations

On June 29, 2010, CTC performed an inspection of the OpenBand headend and hub serving Loudoun County customers. The headend site is located at 43465 Riverpoint Drive in Lansdowne. The site contains the headend building and a standby power generator. The upstairs area of the headend houses satellite reception equipment and the VOD server. The downstairs portion of the headend houses the modulators, Emergency Alert System (EAS), and the remainder of the system equipment, including all lasers, optical receivers, fiber patch panels, modulators, and signal combiners for the OpenBand system. The site also includes redundant HVAC systems and fire-suppression equipment.

The satellite antenna is a single Simulsat antenna that receives programming from multiple satellites. The Simulsat antenna is in a fenced area and includes an integral heating system that melts snow and ice to prevent reception degradation during inclement weather. The Simulsat antenna is located approximately one-quarter of a mile from the Lansdowne headend site. The satellite signals are transported to the headend by a dedicated fiber link.

All headend equipment is backed up by an uninterruptible power supply (UPS) and a generator. The backup generator automatically restores power in the event of failure of the commercial power supply. The UPS provides power during the transition between the commercial power interruption and the start of the generators.

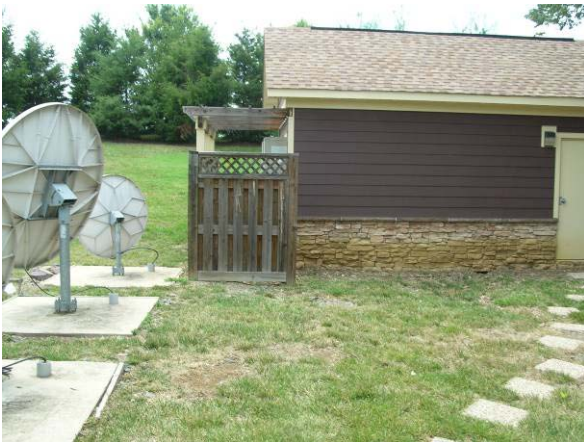
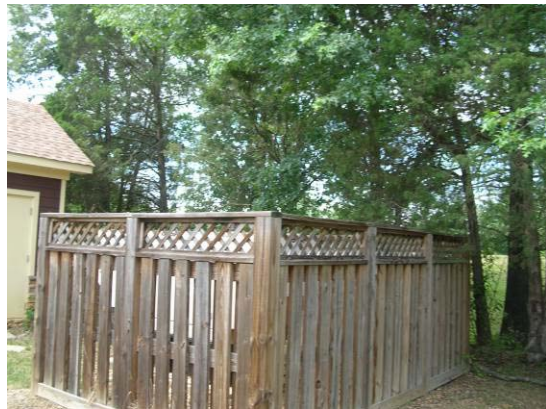
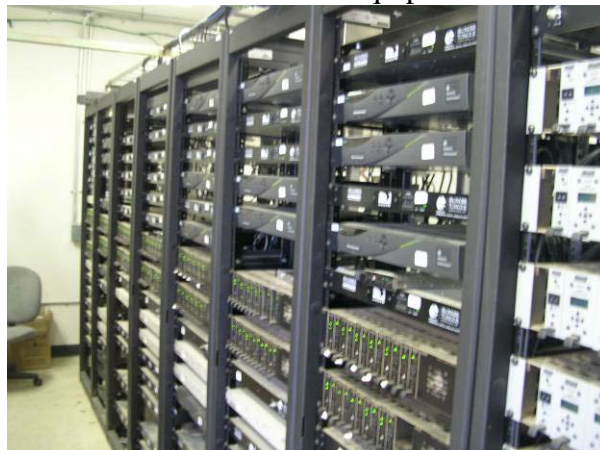
Figure 4: Broadlands Hub Facilities

The OpenBand headend site serves one hub located in the Broadlands subdivision. Originally, the hub site was a standalone headend that received and processed all signals. Several years ago, OpenBand built a fiber interconnect to the Lansdowne headend and converted the Broadlands headend into a hub. The original headend equipment is still on site but not in use. At present, the site receives programming via an OpenBand fiber connection from the Lansdowne headend. A master optical receiver (node) at each hub then provides programming to lasers for distribution to residents served by the hub. The hub site includes the hub building, standby power generator, lasers, optical receivers, and fiber patch panels. The site also includes redundant HVAC systems. Figure 4 illustrates the Broadlands hub facilities.

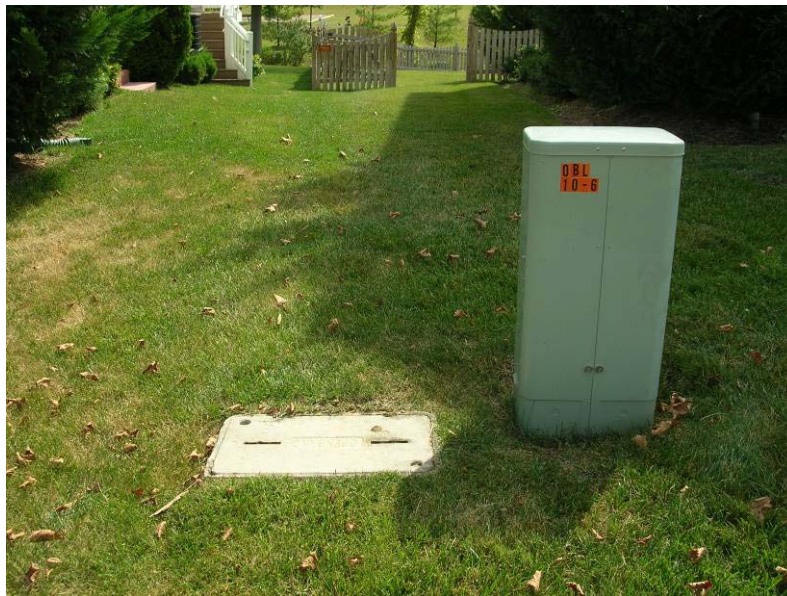
Figure 5: Telephone Pedestal with CATV and Fiber Optic Vault for HSD

The television plant distribution system consists of a fiber-to-the-node architecture with a maximum of two amplifiers in cascade. The OpenBand CATV system bandwidth is 860 MHz using Motorola amplifiers and nodes. The bandwidth is a measure of the capacity of the system to transport television and advanced services to subscribers. The current state-of-the-art for modern systems supports a bandwidth of at least 860 MHz. To minimize the number of pedestals, subscriber television taps are co-located in a common pedestal with the copper telephone lines while the fiber optic drops are located in flush-mount vaults (See Figure 5).

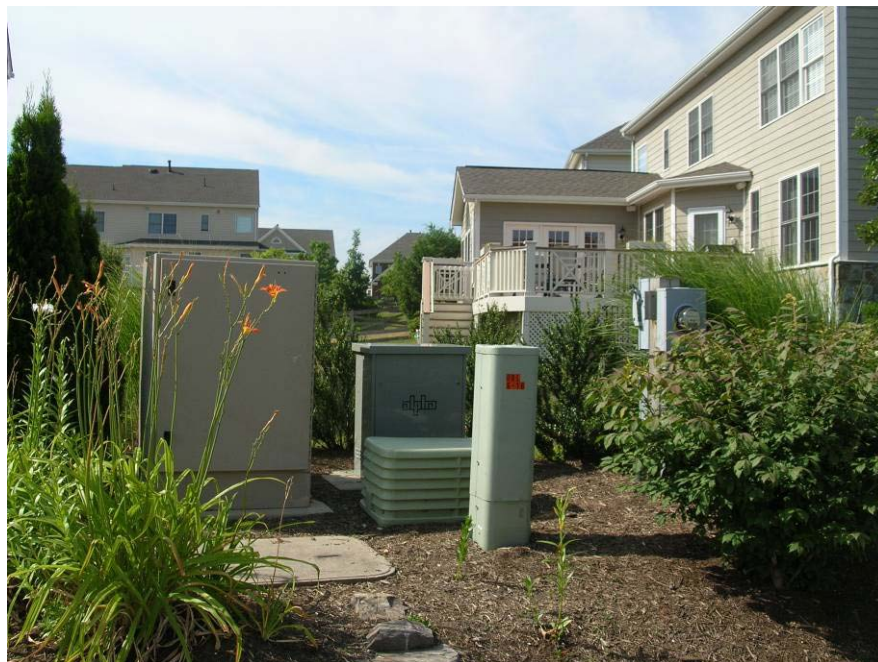
Figure 8: Location Illustrating AON Equipment, Power Supply, Node, and Telephony

OpenBand has three leased 1 Gbps incoming lines from three different carriers using fiber optic cable. They provide cable modem service to approximately 100 residents in Leisure World using the CATV system and DOCSIS 2.0. The residents of Lansdowne and Broadlands receive HSD services over a separate fiber active optical network (AON). The AON uses remote electronics and multimode fiber for the drop to subscribers. The AON cabinet is equipped with batteries to provide standby power for a limited time. Figure 8 illustrates a location with a cable power supply, node, AON equipment, telephony pedestal, and vault containing fiber and drops to homes.

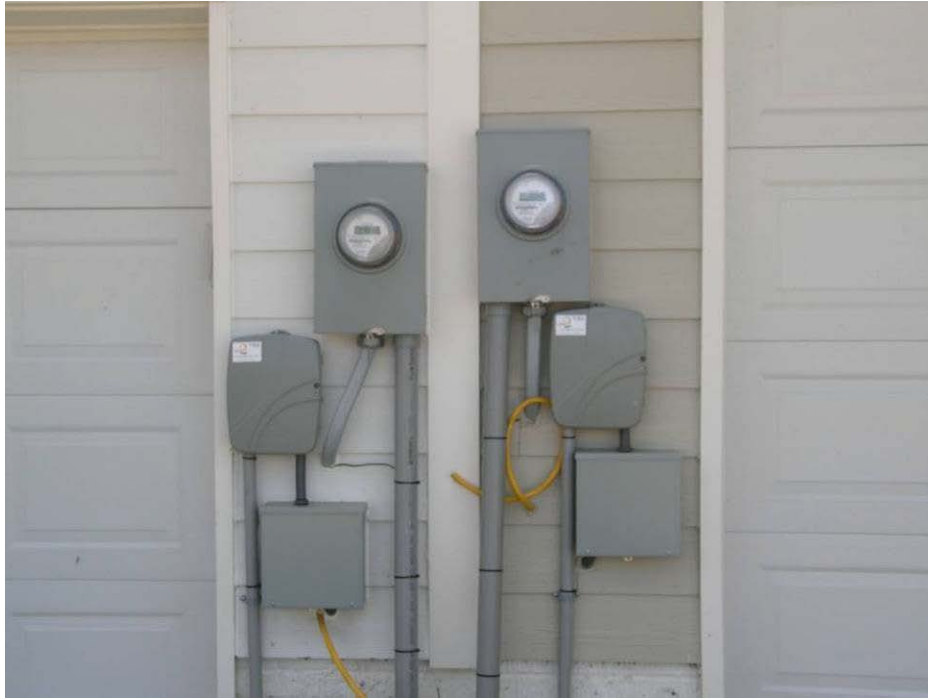
Figure 9: Location Illustrating the PON Equipment at a Subscriber Townhouse

Lansdowne Town Center receives all services (telephone, CATV, and HSD) through a GPON fiber system. No copper wires or coaxial cable are used (see Figure 9).

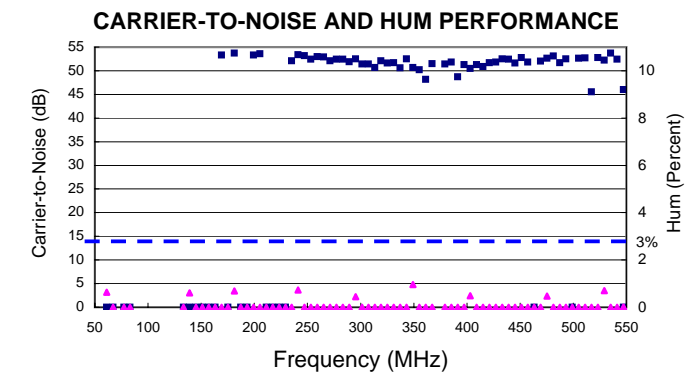
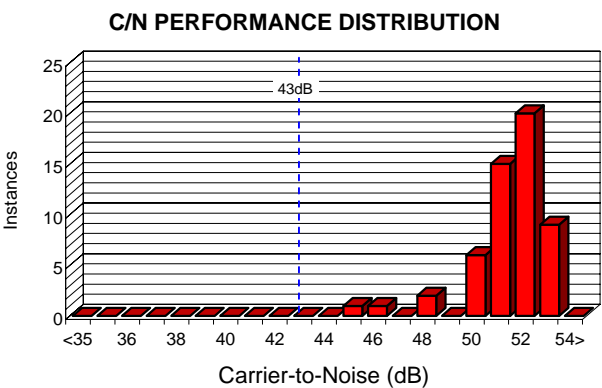
OpenBand Headend 06/29/10

Carrier-to-Noise			
Average	51.9 dB	Min. allowable	43 dB
Carrier Level Variation			
Overall	2.2 dB	Max. allowable	14 dB
Adjacent	1.9 dB	Max. allowable	3 dB
Hum			
Average	0.64%	Max. allowable	3 %
A/V Ratio			
Maximum	15.5 dB	Max. allowable	17 dB
Minimum	14.4 dB	Min. allowable	10 dB

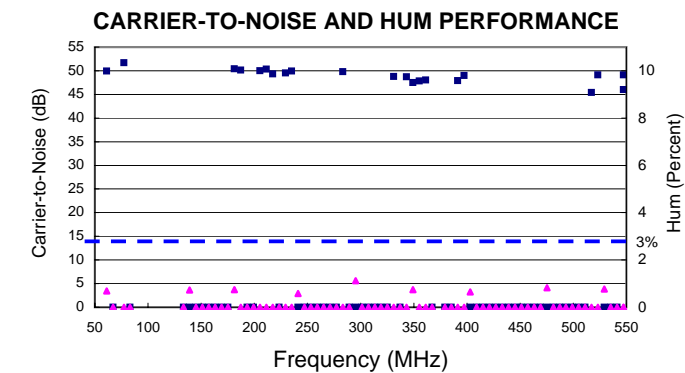
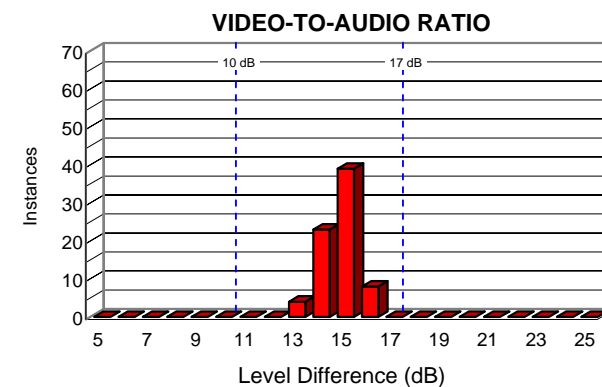
TP01 19262 Mill Site Place 06/29/10

Carrier-to-Noise			
Average	49.1 dB	Min. allowable	43 dB
Carrier Level Variation			
Overall	4.9 dB	Max. allowable	14 dB
Adjacent	2.1 dB	Max. allowable	3 dB
Hum			
Average	0.76%	Max. allowable	3 %
A/V Ratio			
Maximum	16.8 dB	Max. allowable	17 dB
Minimum	13.3 dB	Min. allowable	10 dB

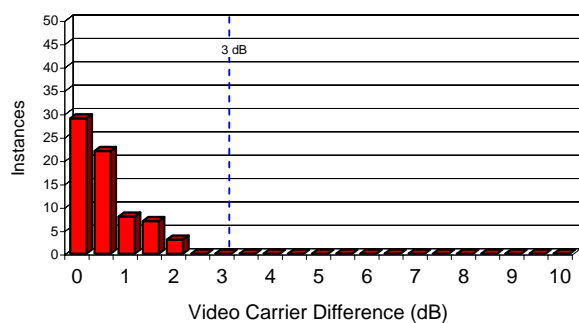
TP04 40433 Milford Drive 06/29/10

Average	48.5 dB	Min. allowable	43 dB
---------	---------	----------------	-------
